DEWETRON

ISSUES & ERRATA

CORRECTIONS AND WORKAROUNDS

Issues and Errata, Release 8.1.0

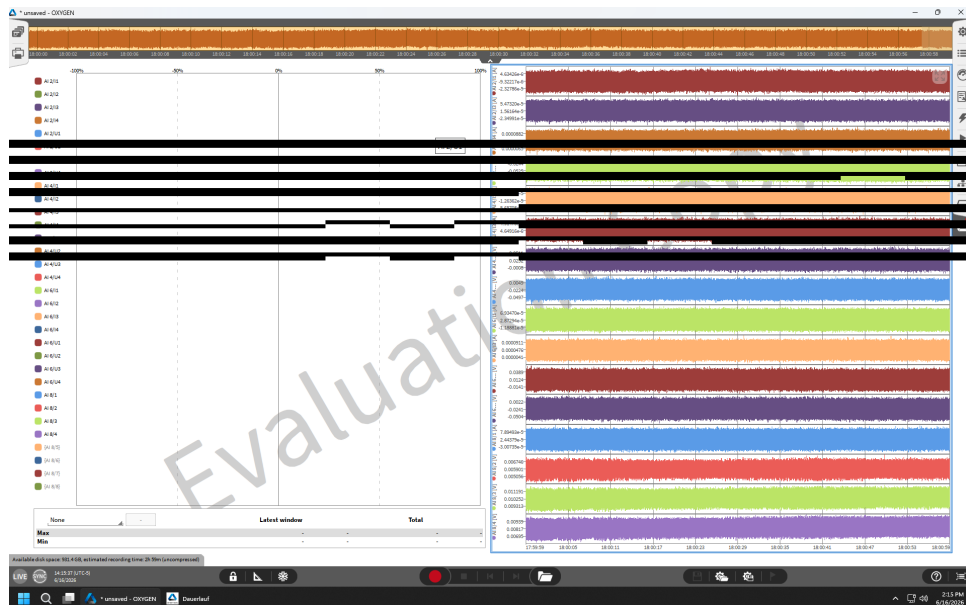
Fig. 2.1: Oxygen Screen Artefacts

Oxygen has random screen artefacts after running for a while on DEWETRON chassis. The artefacts are visible on the screen and can be seen in screenshots. The artefacts are not visible in the recorded data and do not affect the measurement.

The artefacts are only visible on the screen and do not affect the measurement. The artefacts can be seen in screenshots and may be disturbing for the user.

Resetting the Windows Graphics Driver (WDDM) or restarting Oxygen will remove the artefacts. The artefacts may reappear after a while. The driver can be reset by pressing the key combination "Windows + Ctrl + Shift + B". This will reset the graphics driver and remove the artefacts.
